Title: Confirmation of Non-Impacted Status (TA16-280 Complex)

Confirmation of Non-Impacted Status (TA16-280 Complex)

TA-16 D&D MARSSIM Characterization Plan
Structures: TA 16-430 Complex and TA 16-280 Complex
Rev. 0, Dated 8/12/2015

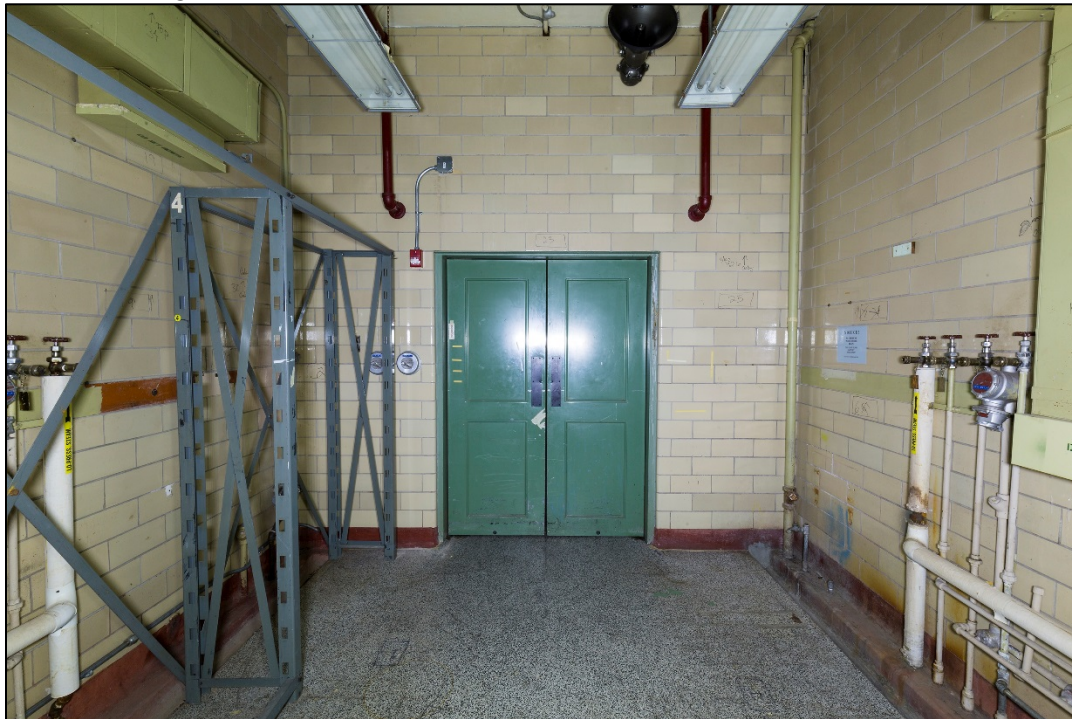
Figure 2. Blast tiles in building 16-280.

Follow-up surveys by radiation control technicians (RCTs) confirmed elevated measurements throughout the building, but revealed one important fact: many of the surfaces reported as bare concrete in the initial survey were actually ceramic tiles. This tile is a specialized material unique to LANL HE buildings of a certain age – it is intended to be blast-proof, and also to dampen the shock wave following an explosion to help preserve building integrity. It is extremely thick, and is more similar to a concrete cinderblock than a traditional ceramic tile. Because so many measurements taken on the blast tiles failed to pass IFB, RCTs removed a sample of the tile and sent it to LANL's Health Physics Analytic Lab (HPAL) for gamma spectroscopy. HPAL results indicated elevated natural thorium in the glaze of the 280-complex blast tiles. This explained the IFB failure for all measurements made on the blast tiles. However, numerous rooms still failed to pass the IFB criteria using a WRS test.

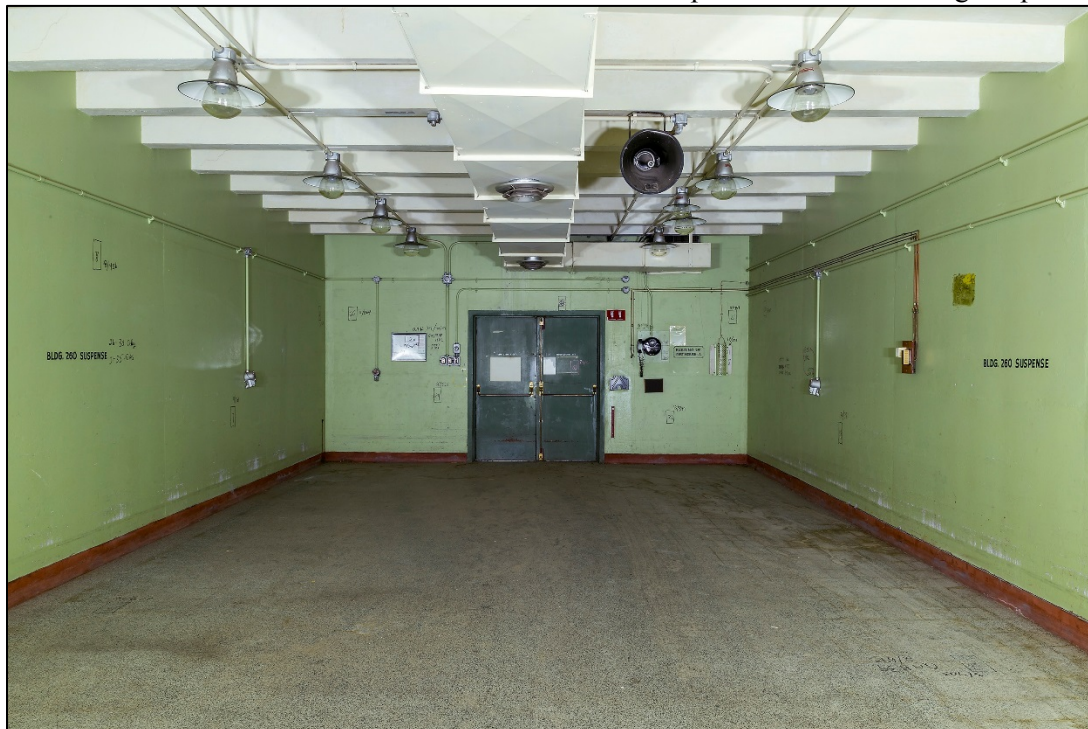
Figure 3. Poured concrete walls in the 16-281 rest house. Note also the specialized metal ceiling lamps.

Despite these measurements, eight rooms were still failing to meet IFB for at least one material type. These materials consisting of painted, galvanized, and rusted metal. From building walk-downs and a careful review of the survey results, it was evident that the painted metal units (which were six of the remaining eight failures) were failing only due to measurements made on specialized blast-proof lamps which were scattered throughout the complex. Other types of painted metal (e.g., building ventilation systems directly adjacent to the lamps) passed as IFB under a WRS test. To evaluate the metal lamps for natural radioactivity, health physics staff made further detailed measurements of these items with a SHP380 a/b coupled to an Eberline E600 and an Exploranium GR-130 miniSPEC. The porcelain-enameled metal shade of the lamp was significantly elevated compared to a reference enameled metal surface. Other parts of the lamp (e.g., the glass shade protecting the bulb) were not elevated. A gamma spectrum acquired via an Exploranium GR-130 miniSPEC indicated the presence of both natural thorium and uranium in the metal lampshade.
